TECHNICAL NOTE 3847

FATIGUE-CRACK-PROPAGATION AND RESIDUAL-STATIC-STRENGTH
RESULTS ON FULL-SCALE TRANSPORT-AIRPLANE WINGS

By Richard E. Whaley, M. J. McGuigan, Jr.,
and D. F. Bryan

December 1956

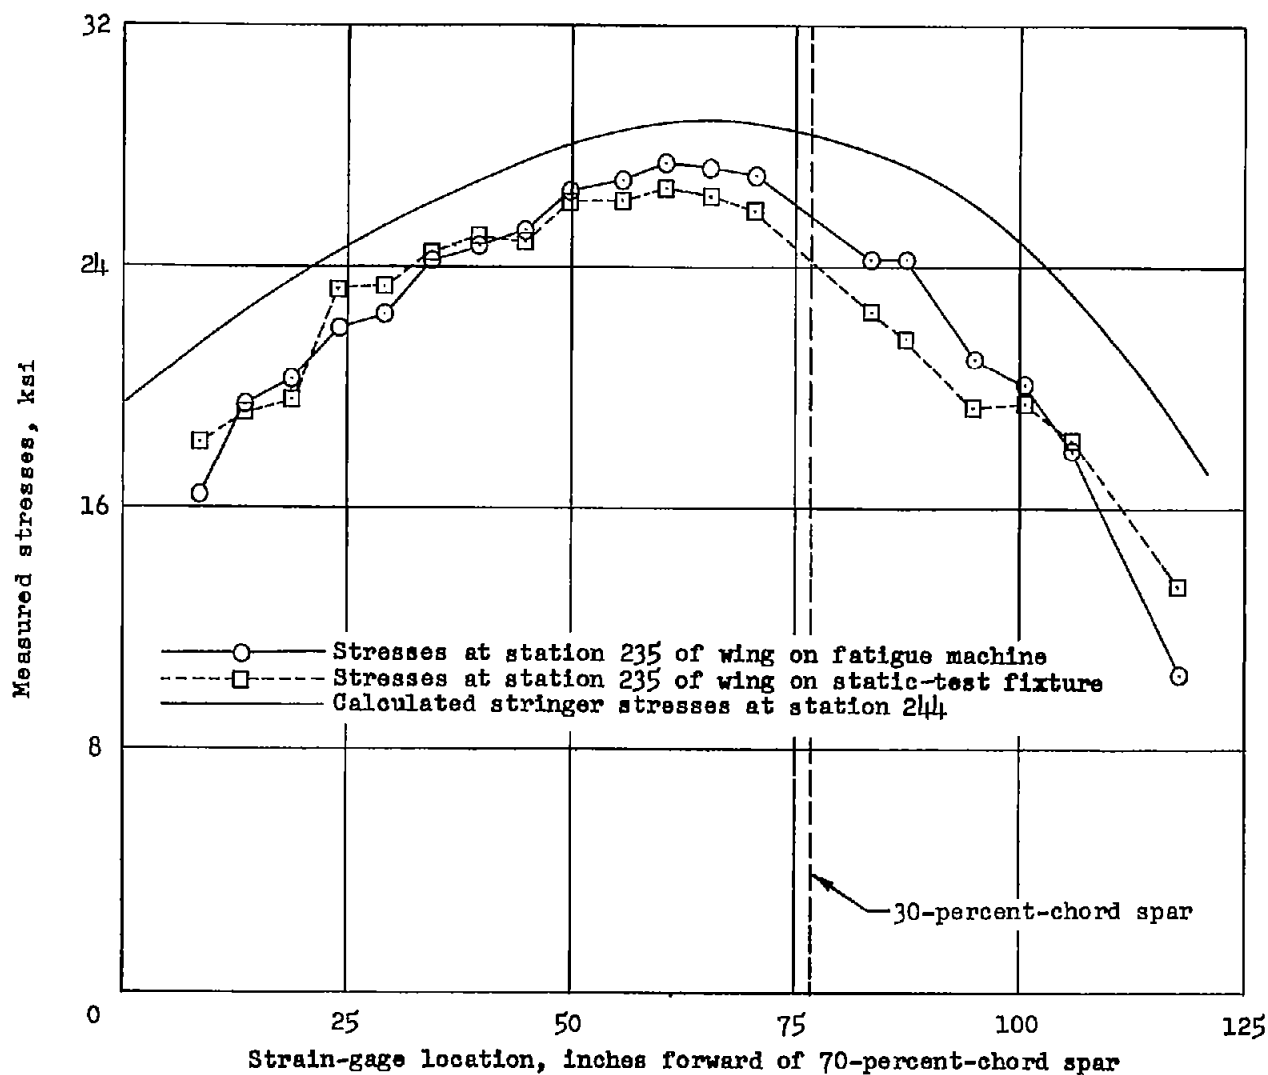
The stress distribution in the wing when loaded on the static-test fixture was very nearly the same as that when the outer panels were loaded while attached in the normal manner on the wing center section in the fatigue testing machine. The chordwise stress distribution is shown in figure 10 for a loading of 4.0g which is applied in both loading devices. The station chosen for this survey (station 235) was the closest station to the area of interest which was free of cutouts, doublers, and other discontinuities. It may be seen from this figure that the chordwise location of the points of maximum stress agrees well with each other and that the difference between the curves obtained from the two loading systems is small. Also included in this figure for comparison is the chordwise distribution of design bending stresses obtained from the structural analysis of the airplane.

Figure 10.- Chordwise distribution of skin and stringer stresses for 4.0g loading.

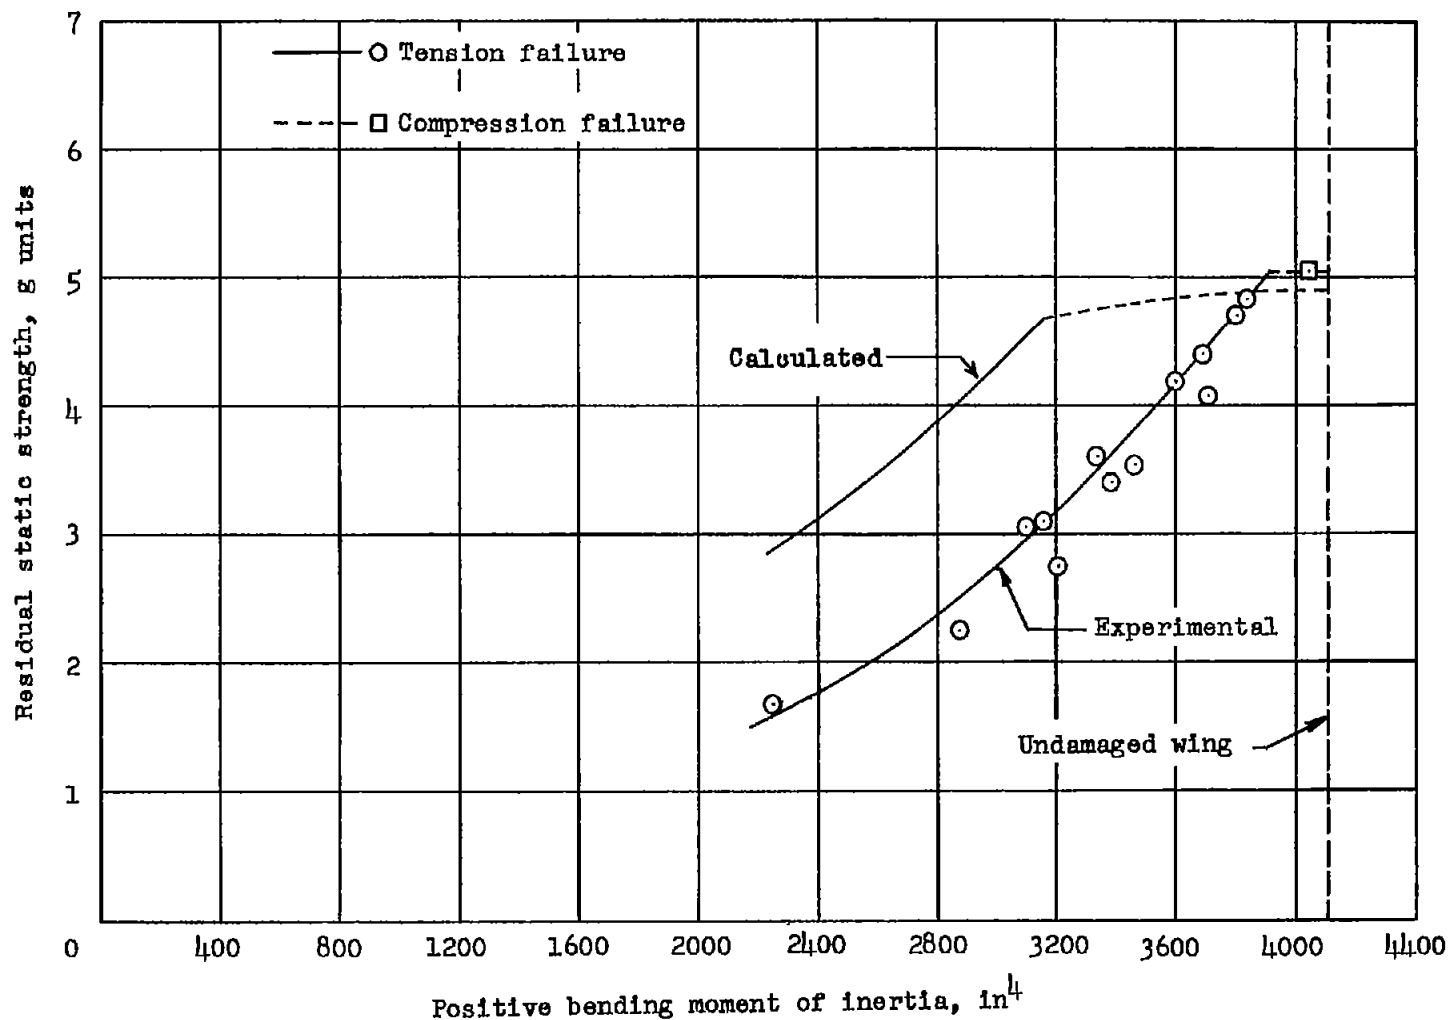
The residual static strength of the C-46 wing based on design-load considerations was very good, as indicated by figure 12, principally because of the large margins of safety in the lower surface of the wing for the positive-loading case. These large margins resulted in relatively small reduction in the bending strength of the whole wing even though the strength of the tension surface itself had been considerably reduced. The large margins of safety for the positive design load were occasioned by the fact that the lower surface of the wing was critical in the negative-loading case in which very small margins were present. In other words, in order to have adequate strength for the negative design load, the lower surface had excess strength in the positive-design-load case.

Figure 12.- Residual static strength of C-46 wing in positive bending.

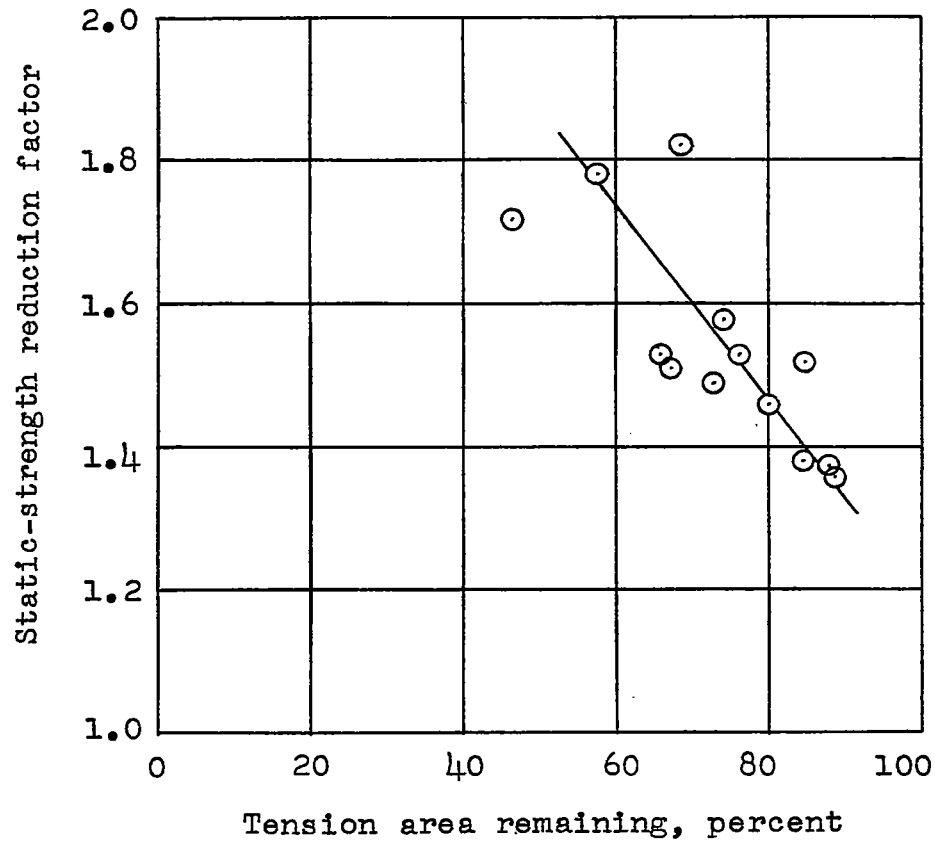
It can be seen in figure 13 that the actual strength is less than the calculated strength by about the same amount throughout the range of the test values. This reduction amounts to about 23 percent of the static strength of an undamaged wing. This reduction in strength can also be expressed as a static-strength reduction factor which is defined here as the ratio between the calculated strength and the actual strength at the same percentage of material remaining. This factor is calculated for each wing and is listed in table III. In figure 14 this static-strength reduction factor is plotted against the percent of tension area remaining in the wing. This figure indicates that as the amount of tension area remaining in the wing decreases the static-strength reduction factor increases. This increase is due to the static strength decreasing while the difference between the calculated strength and the actual strength remains constant. This factor can be used directly along with the calculated strength to find the actual strength.

Figure 14.- Static-strength reduction factors for C-46 wing.

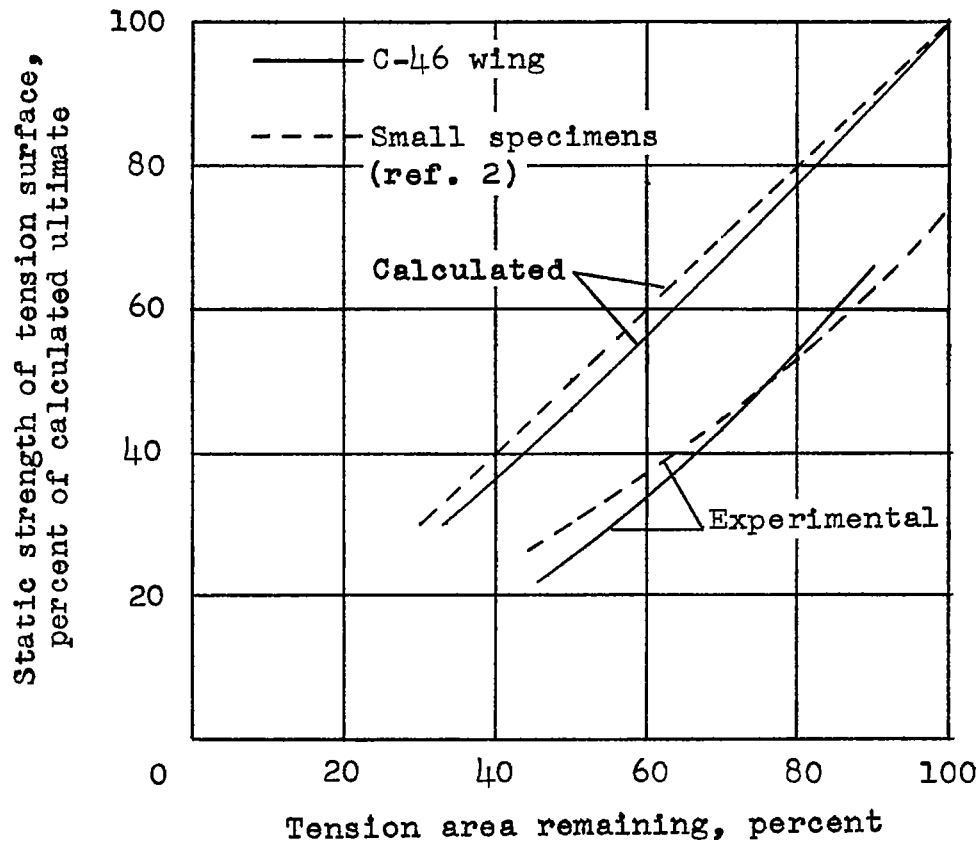
In figure 15 the residual static strength of the wing tension surface is compared with the results of tension tests conducted on $2\frac{1}{4}$ -inch-wide 2024-T3 aluminum specimens (ref. 2). It can be seen that there is remarkably good agreement between the two. Extrapolation of the results of the full-scale tests to near the region of the undamaged wing indicates that a considerable reduction in static strength of the tension surface would result from a very small fatigue crack.

Figure 15.- Comparison of residual static strengths of C-46 wing and small specimens.
